# HDG DATASHEET: 16

## Staining and Discolouration of Hot Dip Galvanized Steel

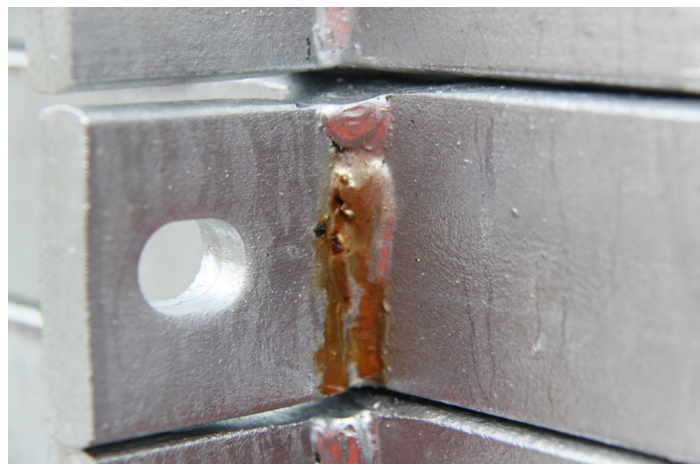
Staining and discolouration sometimes takes place at or adjacent to welds as a result of weld seepage (Fig 1.) This occurs as a result of pretreatment solutions used to clean the steel prior to hot dip galvanizing becoming trapped in weld pin holes. The heat of the galvanizing process drives off any moisture leaving behind a residue in the pin holes. However, when externally exposed, moisture is drawn into the pin holes by capillary action and the residue dissolves and then seeps out to give a reddish/brown discolouration. Such staining may be removed by wire brushing and provided all the residue has seeped out, staining should not reoccur.

Fig 1. Weld seepage staining

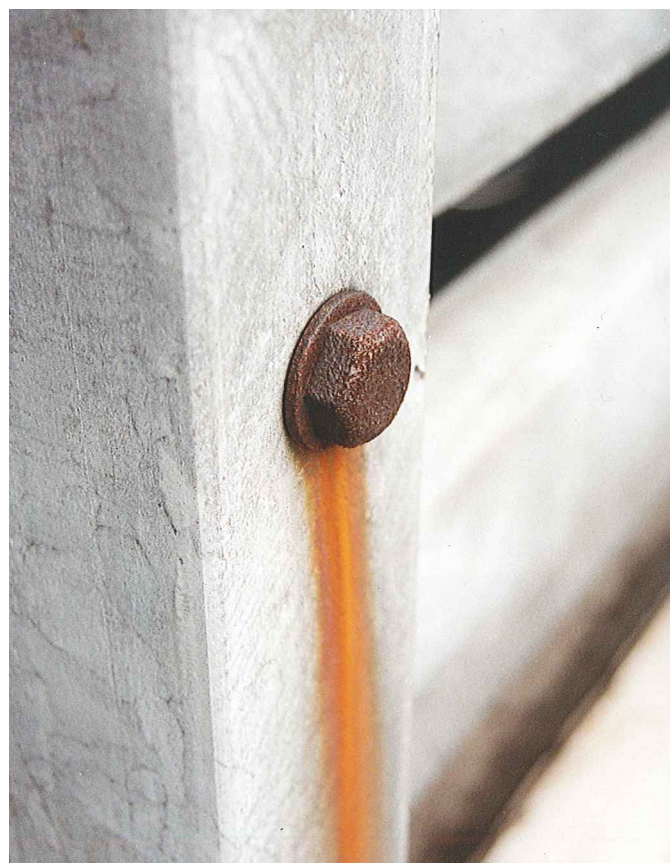
If water runs off uncoated steelwork it will contain a small amount of dissolved iron. If such water runs onto a galvanized surface and subsequently dries out, it gives a reddish/brown stain (Fig 2.)

If galvanized steelwork is subject to mechanical damage, or it is welded with inadequate repair being conducted, then the exposed area may corrode leading to staining and discolouration of the surrounding sound galvanized coating. Rust staining may be removed by mild abrasion or cleaning with commercial grade oxalic acid, the latter process requiring subsequent washing down with fresh water. It is essential though that any exposed surfaces are repaired so as to prevent possible future corrosion and staining.

Fig 2. Corrosion of uncoated fastener resulting in rust staining of the galvanized surface
